## BMW E61

### fixing tailgate wiring problems

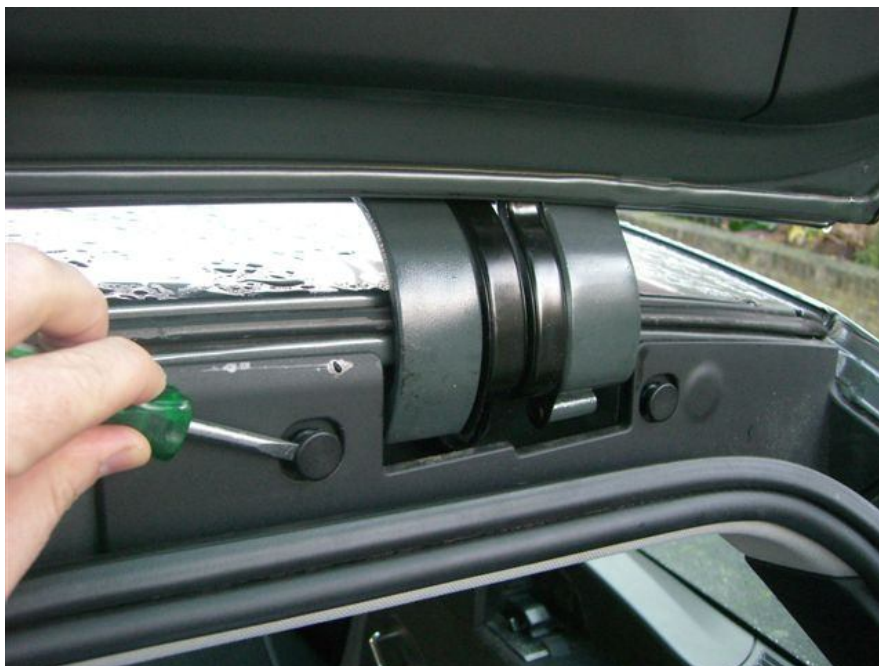
I opened the complete boot (not the glass lid, keep it closed for the moment), and removed the 3 plastic covers from the right hand side hinge by prying out the plastic plugs as shown here (use a wide flat screwdriver):

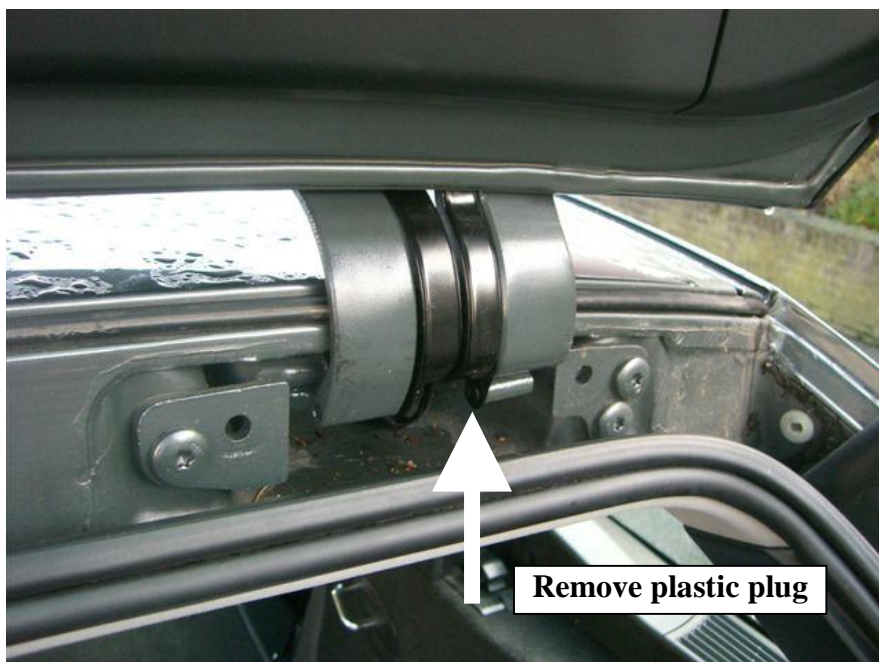
Now the cover is removed. Next step is to remove the plastic plug that holds the lower part of the rightmost wire guide:

I was not able to remove the plug in one piece, I had to cut it. I decided to buy new plugs and put these back later. Suggestions are welcome how to remove this plug in 1 piece ...

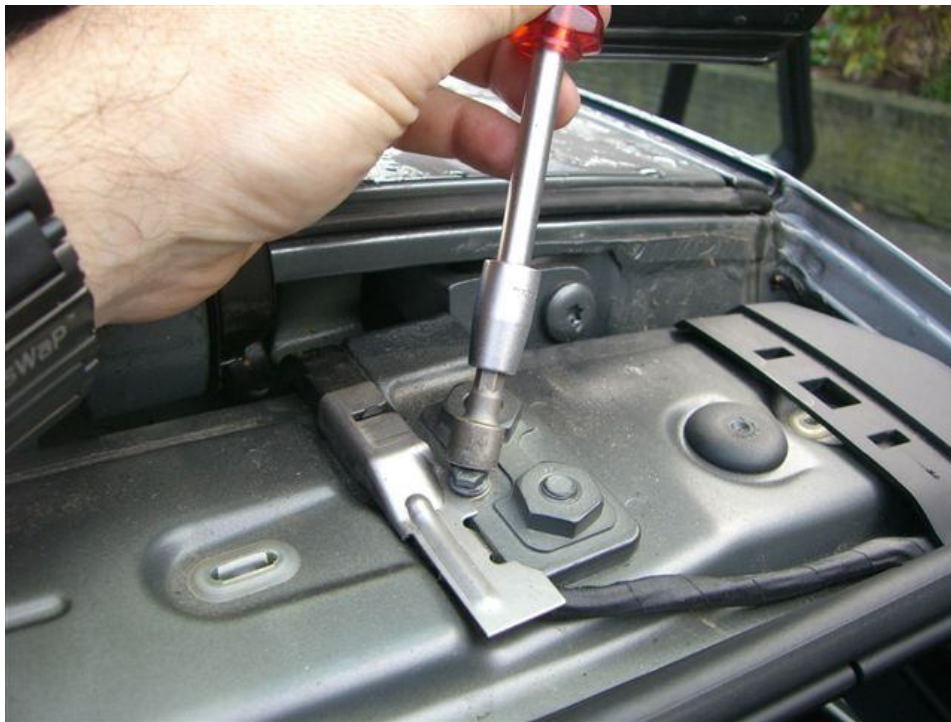
Now, close the boot and open the glass lid (I hope your glass lid switch is still working...). Now you see the upper side of the rightmost wire guide. Unscrew the metal cover with this screw:

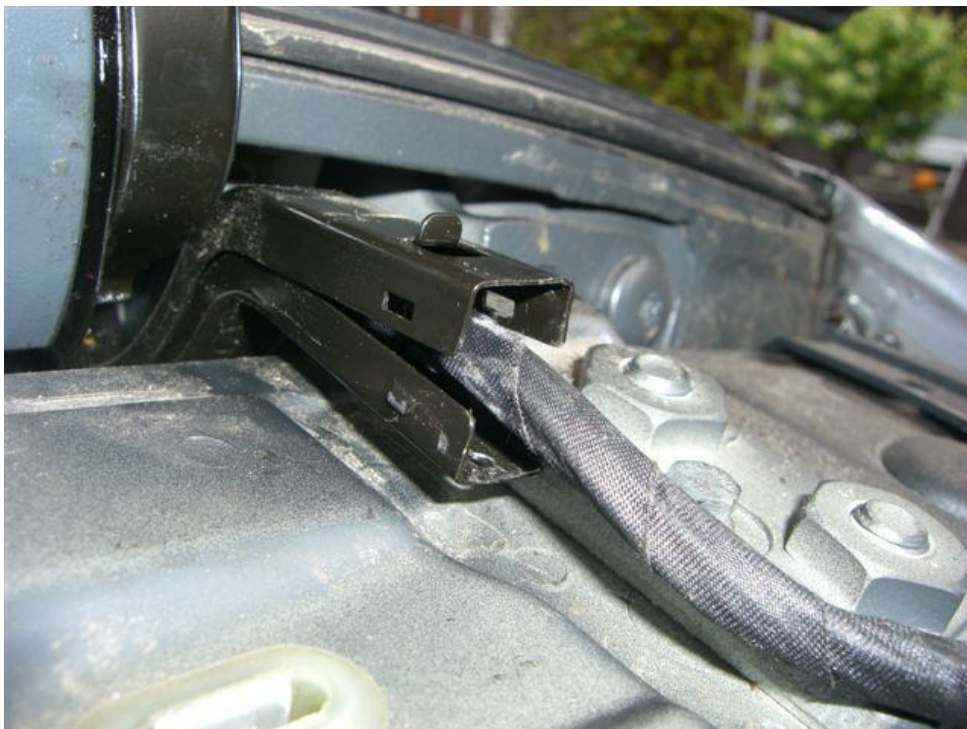
Open the metal guide with a flat screwdriver. Be carefull with your fingers...

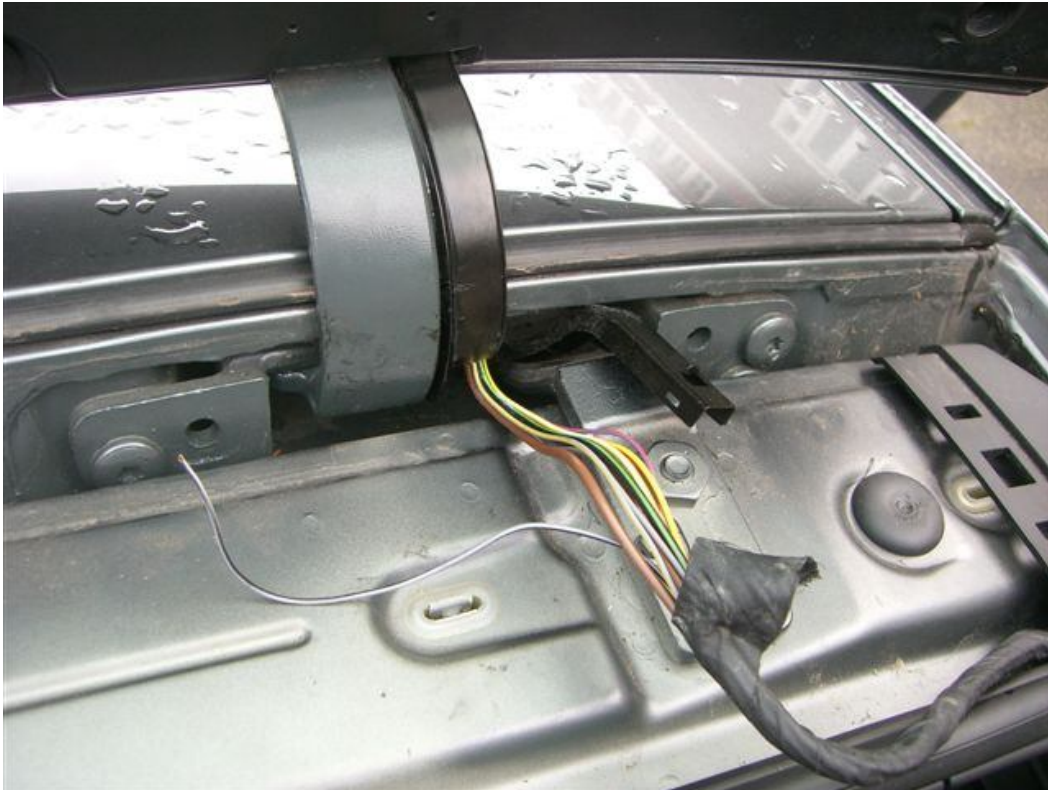
Now remove a bit of the black tape and here you see one of my problems: the grey/black cable was broken off completely, which runs to the right license plate light:

My E61 started with these problems in the summer of 2009 at 140.000 kilometres, 5 years of age. The root cause of the shorts and bad contacts are the metal wire guides which (should) protect the wires from the chassis to the boot door. First of all, there is not enough space in these metal guides: the wires are really squeezed together. Secondly, I noted sharp edges within these guides which eventually cut the wires after some years of usage. Personally I decided to get rid of the two outmost covers completely.

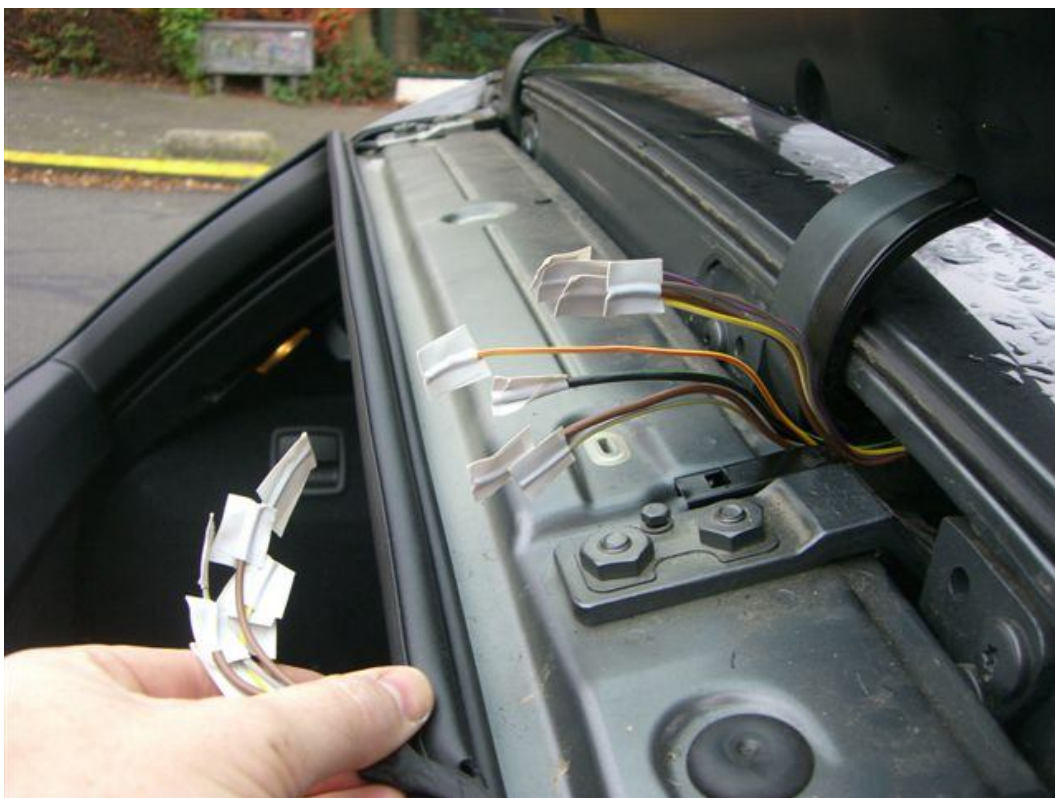
I then went back to the outside and cut all 9 wires, but I isolated them before I retired them from the interior:

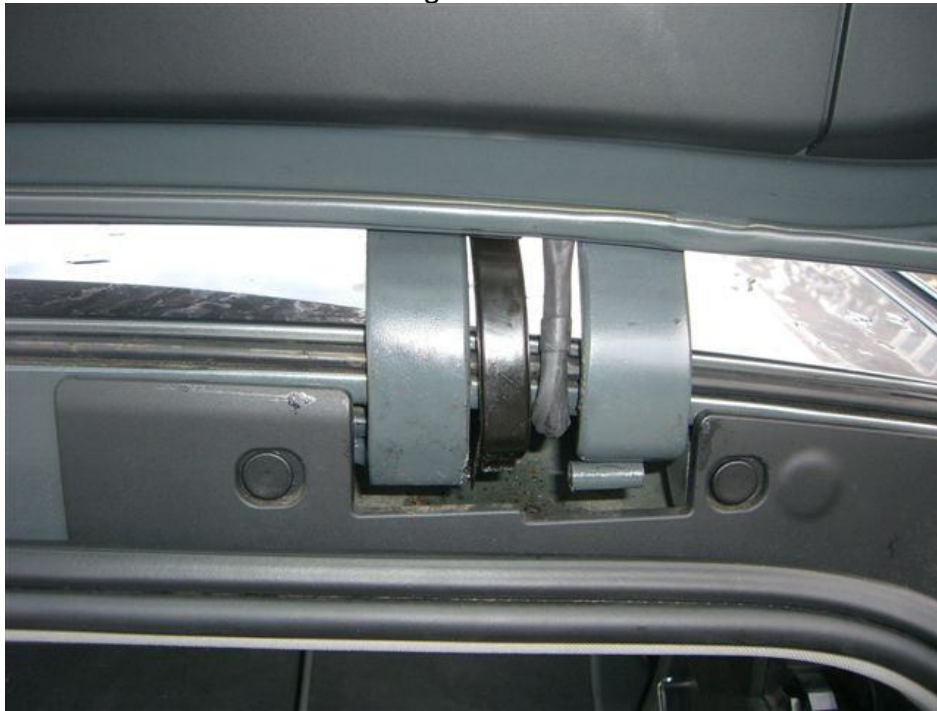
Finally I decided to not use the metal guide again, but instead I shrink wrapped all 9 wires together like this:

The reason why I did not put back the metal guide is that I had no more plastic plugs to hold the guides into the hinges. When I find the time I will surely do that. But for now everything works....

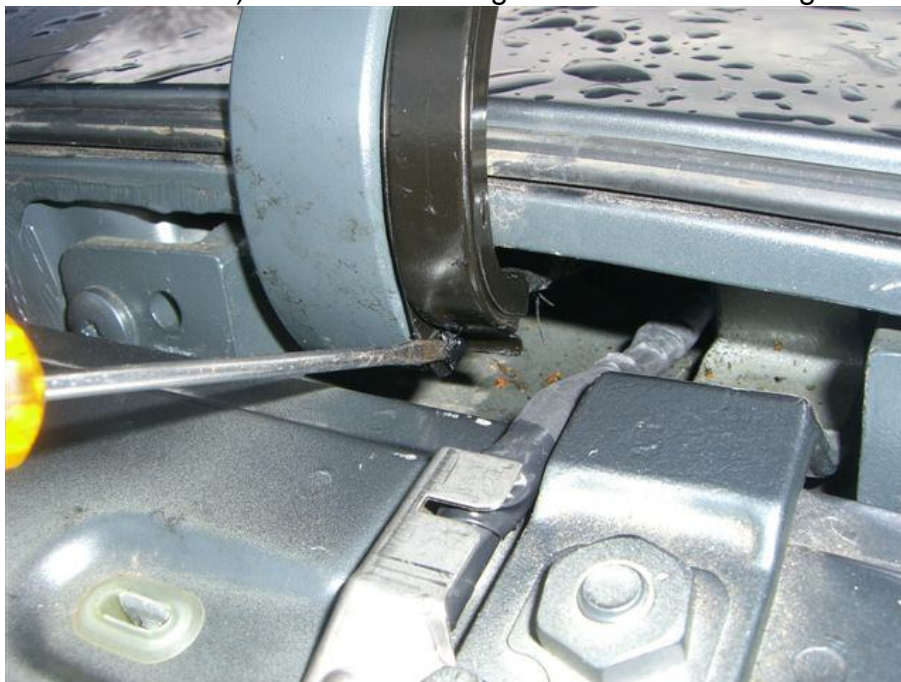
Except for: the !@(\*&@\$!! **glass boot switch** ! To fix that problem, I needed to uncover the guide next to the one I fixed above (nr 3 in my first picture).

To do that, I opened the glass lid again and removed the plastic plug (with a flat screwdriver) which holds this guide nr.3 into the hinge:

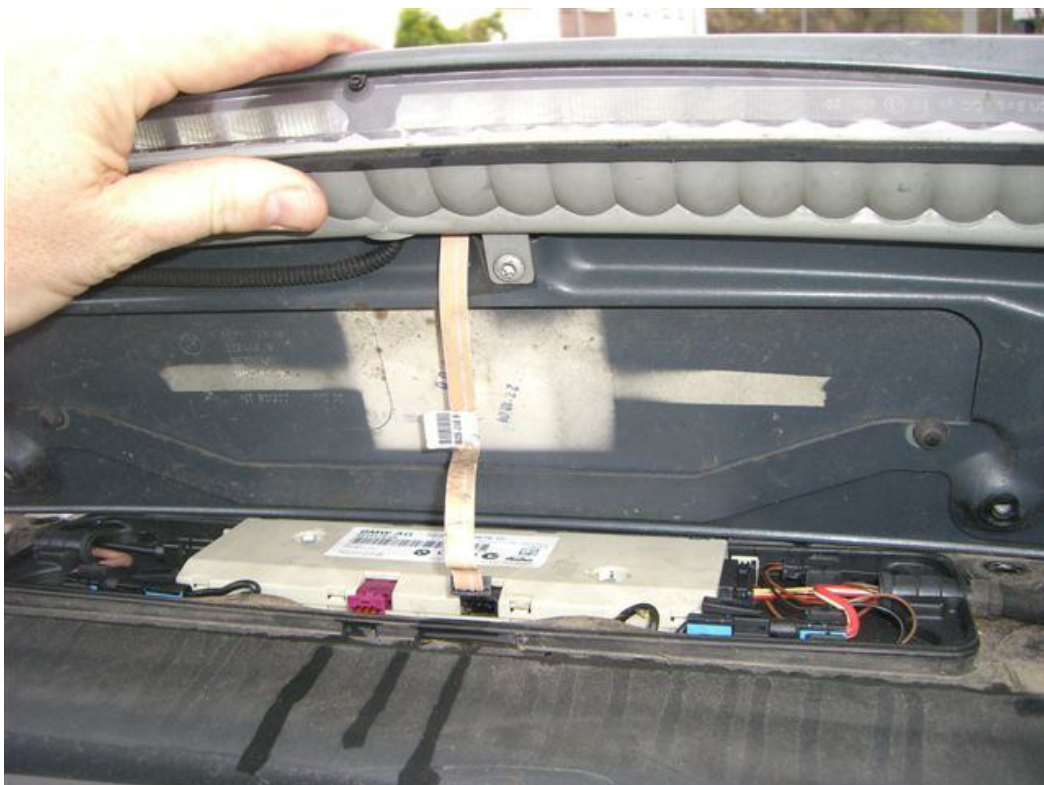
Keeping the glass lid horizontal, I was now able to remove the spoiler by pulling it gently towards me. I opened the spoiler carefully, and opened the black cover of the radio receiver module. In the middle there is an antenna cable still connected:

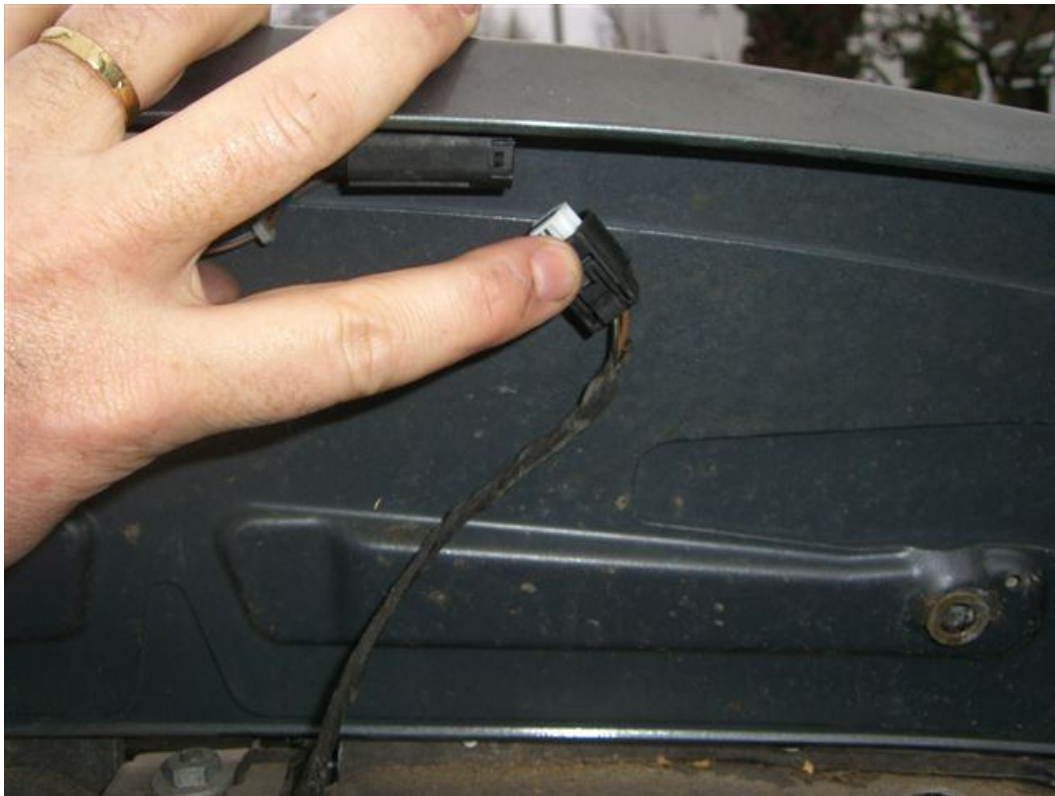
I removed this antenna cable, and on the right hand side I unplugged the high breaking light connector:

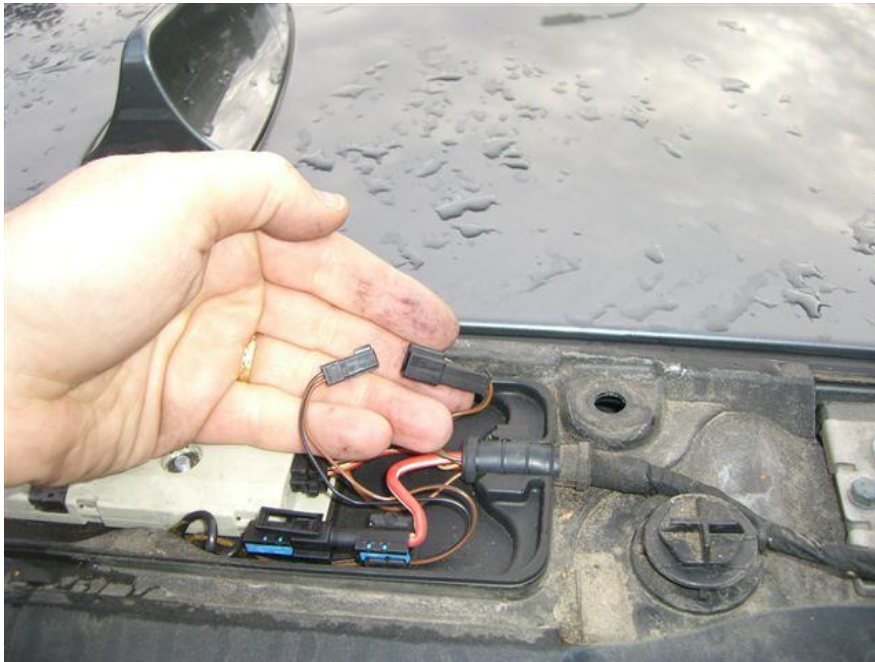
And here is the connector which goes to the glass lid switch:

This is where my story ends, because I simply decided to unplug this connector. I rarely use the glass lid, so hopefully this should now fix my intermittent problem (lid opened itself regularly).
